QUARTERLY UPDATE

FROM JANUARY 1, 1993 THROUGH APRIL 1, 1993

HISTORICAL RELEASE REPORT (HRR)

EG&G ROCKY FLATS, INC.

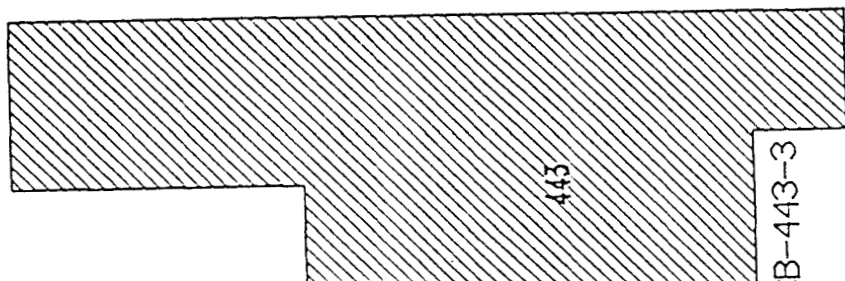
SITE No. 443-2
(special)

Transformer 443-2 is located near the southwest corner of Building 443. The transformer was observed leaking small quantities of oil during a routine inspection in April of 1992. The area is surrounded by a concrete berm and restricted by a fence.
